Manhole Inspection Summary

Manhole # S61U__010MH

Insp Date: **3/4/08 10:41 AM**

Location Address: **5300 Holabird Ave.**

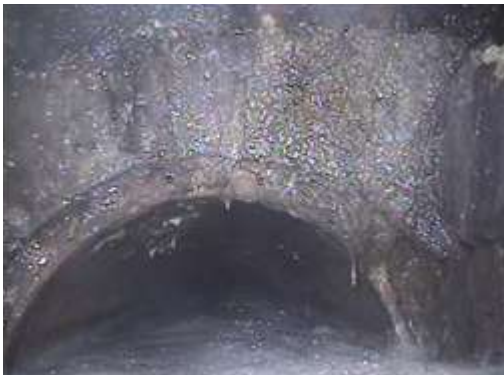
Defect 1

Mineral deposits on barrel.

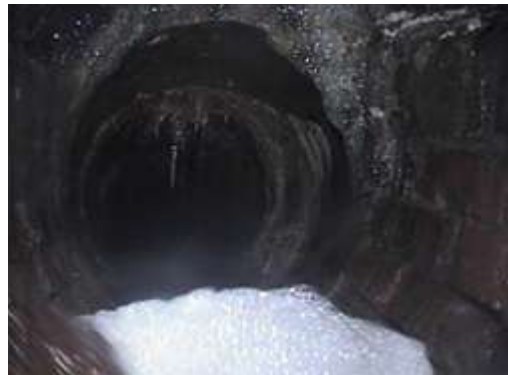
Defect 2

Roots medium 11:00-1:00 10%. incoming 6 O'Clock

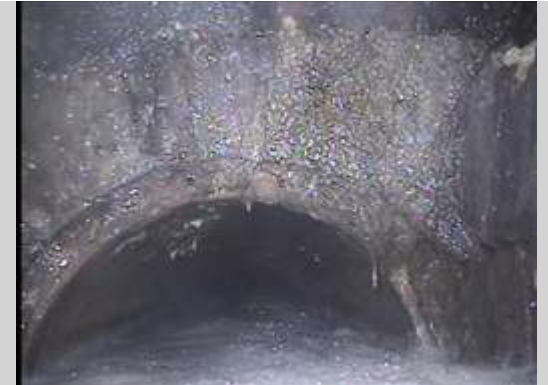
12 O'Clock Outflow

15 in. Circular Gravity Sewer
Pipe Out @ 12 O'Clock

Pipe Height: **15.6** (in.) Rod and Bar (Angled)
Pipe Material: **Clay** ☐ Pipe Lined
Invert Depth: **11.83** (ft.) Flow Characteristics: **Fast**
Deposits: ☒ None ☐ Mud ☐ Sludge ☐ Debris ☐ Grease
Silt Depth: (in.) Deposits Extent:
Infiltration: **None** Pipe Seal Cond: **Sound**

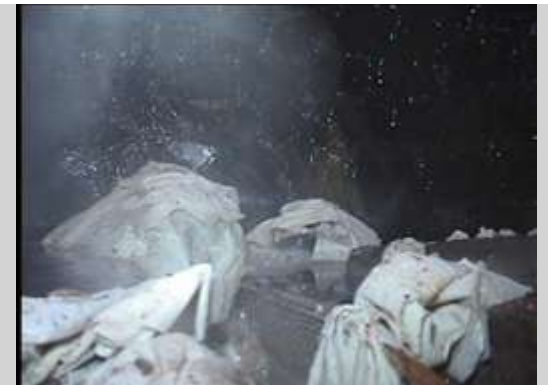
3 O'Clock Inflow

8 in. Circular Gravity Sewer
Pipe In @ 3 O'Clock

Pipe Height: **8.4** (in.) Rod and Bar (Angled)
Pipe Material: **Clay** ☐ Pipe Lined
Invert Depth: **10.67** (ft.) Flow Characteristics: **Slow**
Deposits: ☐ None ☐ Mud ☐ Sludge ☒ **Debris** ☐ Grease
Silt Depth: **4** (in.) Deposits Extent: **Heavy**
Infiltration: **None** Pipe Seal Cond: **Sound**

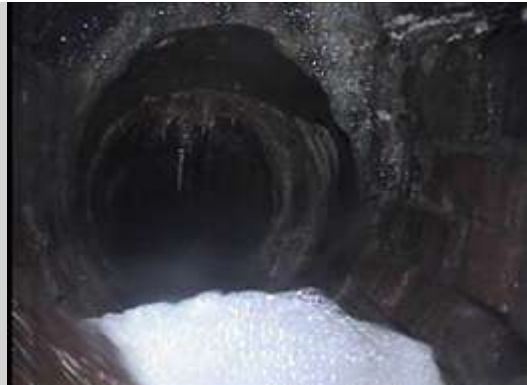
6 O'Clock Inflow

15 in. Circular Gravity Sewer
Pipe In @ 6 O'Clock

Pipe Height: **15.6** (in.) Rod and Bar (Angled)

Pipe Material: **Clay** ☐ Pipe Lined

Invert Depth: **11.17** (ft.) Flow Characteristics: **Fast**

Deposits: ☒ None ☐ Mud ☐ Sludge ☐ Debris ☐ Grease

Infiltration: **None** Pipe Seal Cond: **Sound**
